TECHNICAL REPORT NO. 303

The Replacement of the Shaft Couplers in Las Campanas in 2008 March

Steven J. Hale

2008 April 23

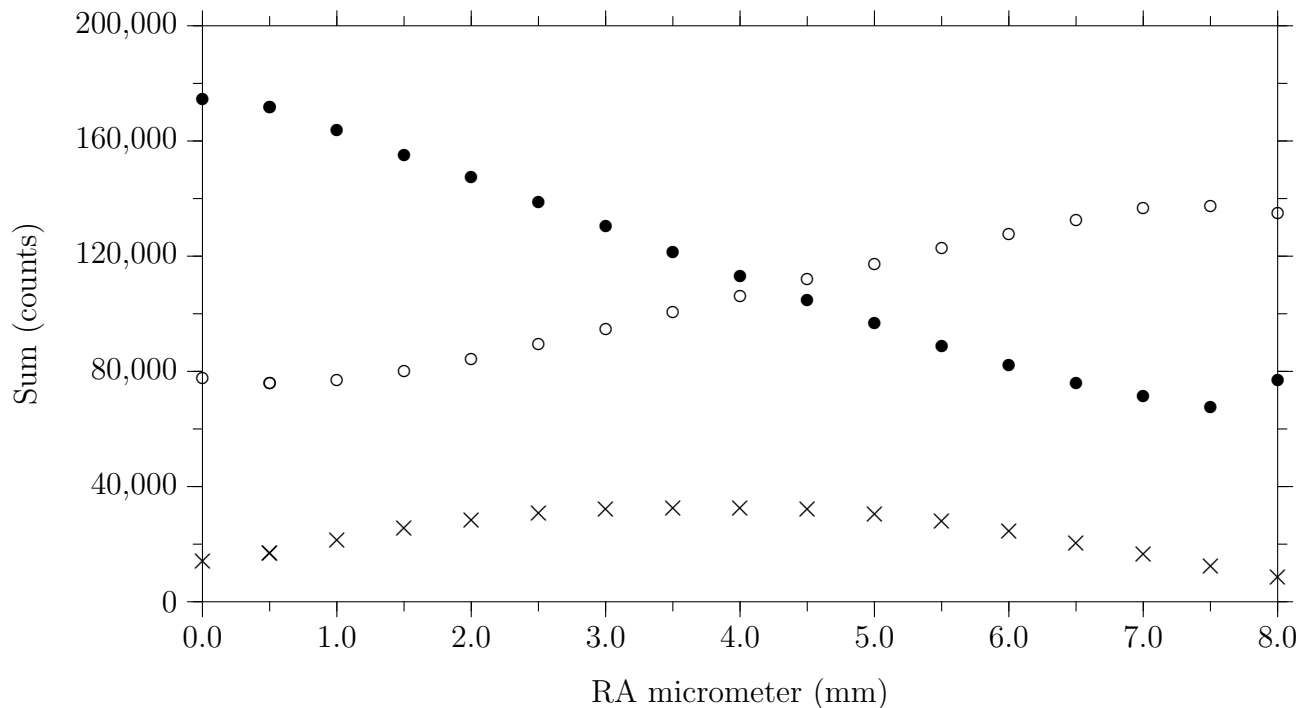
Two autoguider scans were performed on March 20 in order to check the alignment of the mount. The results of the right-ascension scan are shown in Figures 1 and 2. It looks like Hannibal is centered when the right-ascension micrometer is set to 4.25 mm and Ivan is centered at 3.25 mm. A compromise of 4.0 mm seems to be the best, slightly favouring Hannibal the primary instrument. The initial setting was in fact 4.0 mm and so no improvement was made here.

Figure 1: RA scan (Hannibal) - The guider was scanned right ascension. The plot shows how the starboard sum (●), port sum (○), and the transmission monitor (×) varied. This scan was done with the declination micrometer set at 2.25 mm and the cell hot.

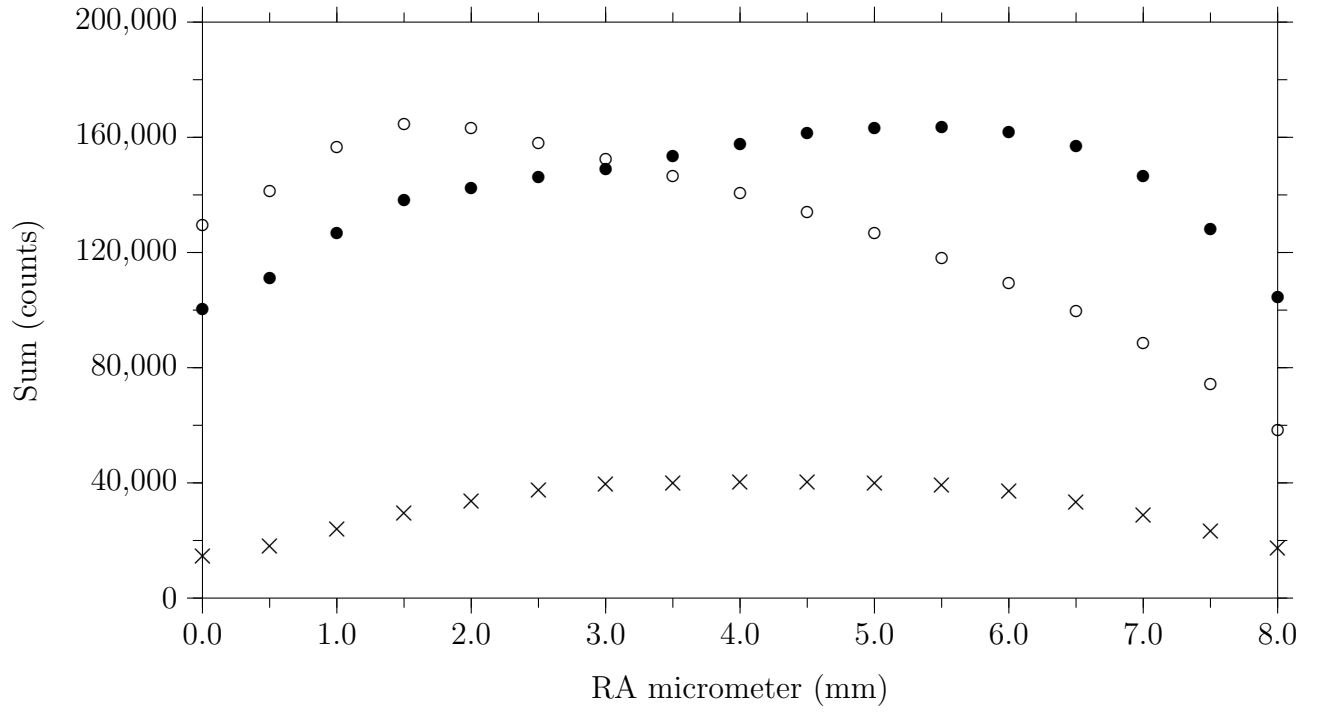
Figure 2: RA scan (Ivan) - The guider was scanned right ascension. The plot shows how the starboard sum (●), port sum (○), and the transmission monitor (×) varied. The transmission monitor data have been divided by ten. This scan was done with the declination micrometer set at 2.25 mm and the cell hot.

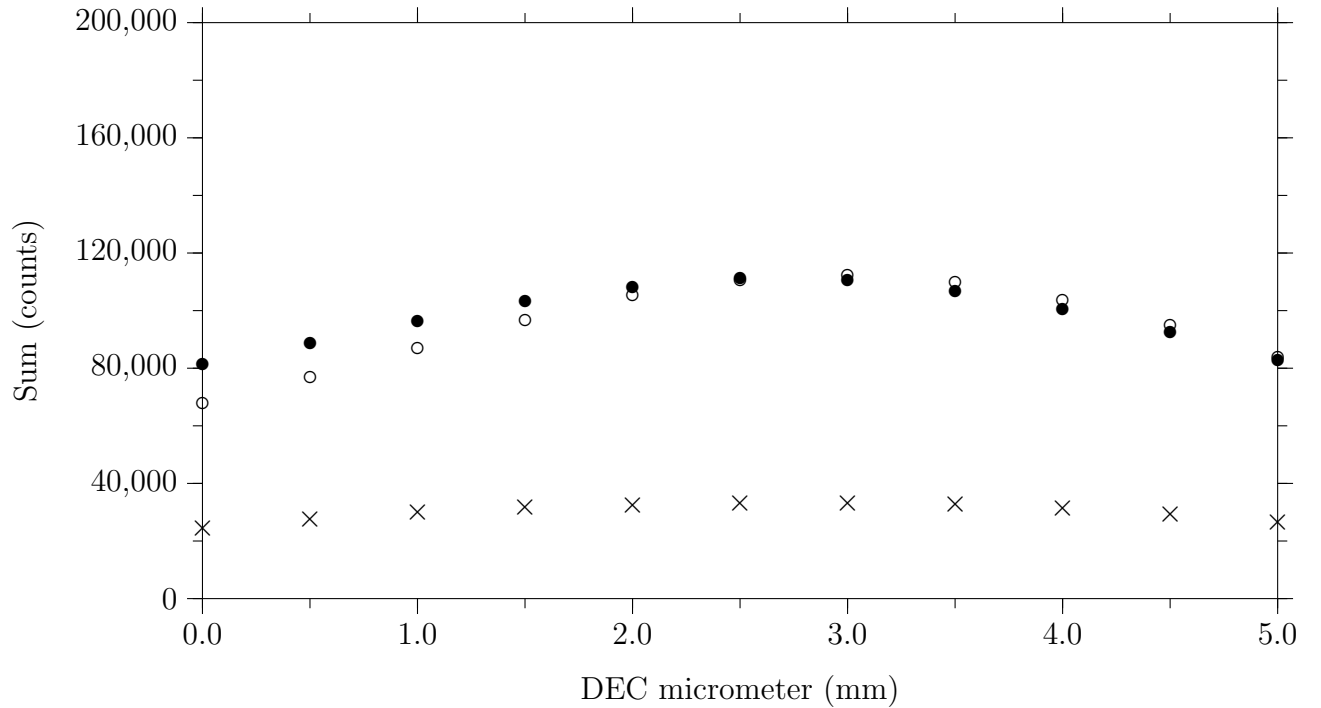
The results of the declination scan are shown in Figures 3 and 4. It looks like Hannibal wants the declination micrometer set to 2.5 mm while Ivan wants 1.5 mm. The best compromise here seems to be a setting of 2.0 mm. The initial setting was 2.25 mm and so a slight improvement was made.

Figure 3: DEC scan (Hannibal) - The guider was scanned declination. The plot shows how the starboard sum (●), port sum (○), and the transmission monitor (×) varied. This scan was done with the right ascension micrometer set at 4.0 mm and the cell hot.

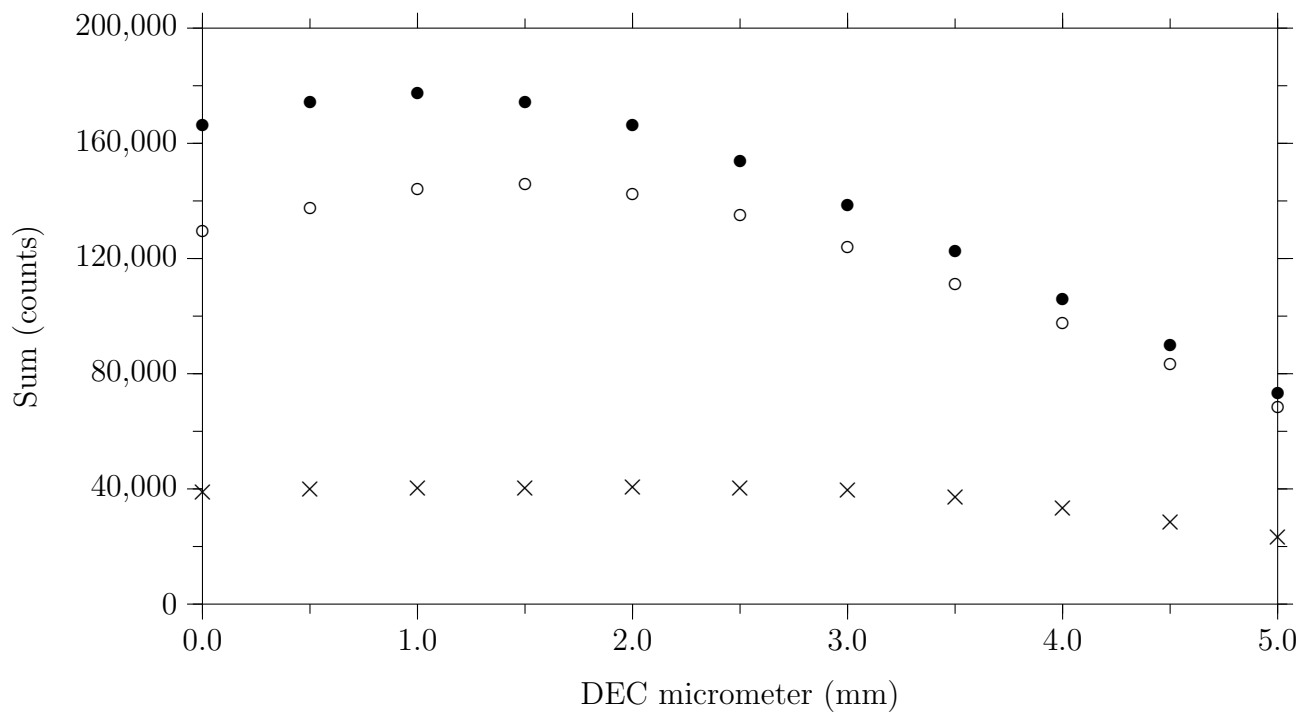
Figure 4: DEC scan (Ivan) - The guider was scanned declination. The plot shows how the starboard sum (●), port sum (○), and the transmission monitor (×) varied. The transmission montior data have been divided by ten. This scan was done with the right ascension micrometer set at 4.0mm and the cell hot.
